## **Limited Visual Dam Safety Inspection Summary Report**

**MA-125**

**Happy Valley Flood Protection**

**May 2006**

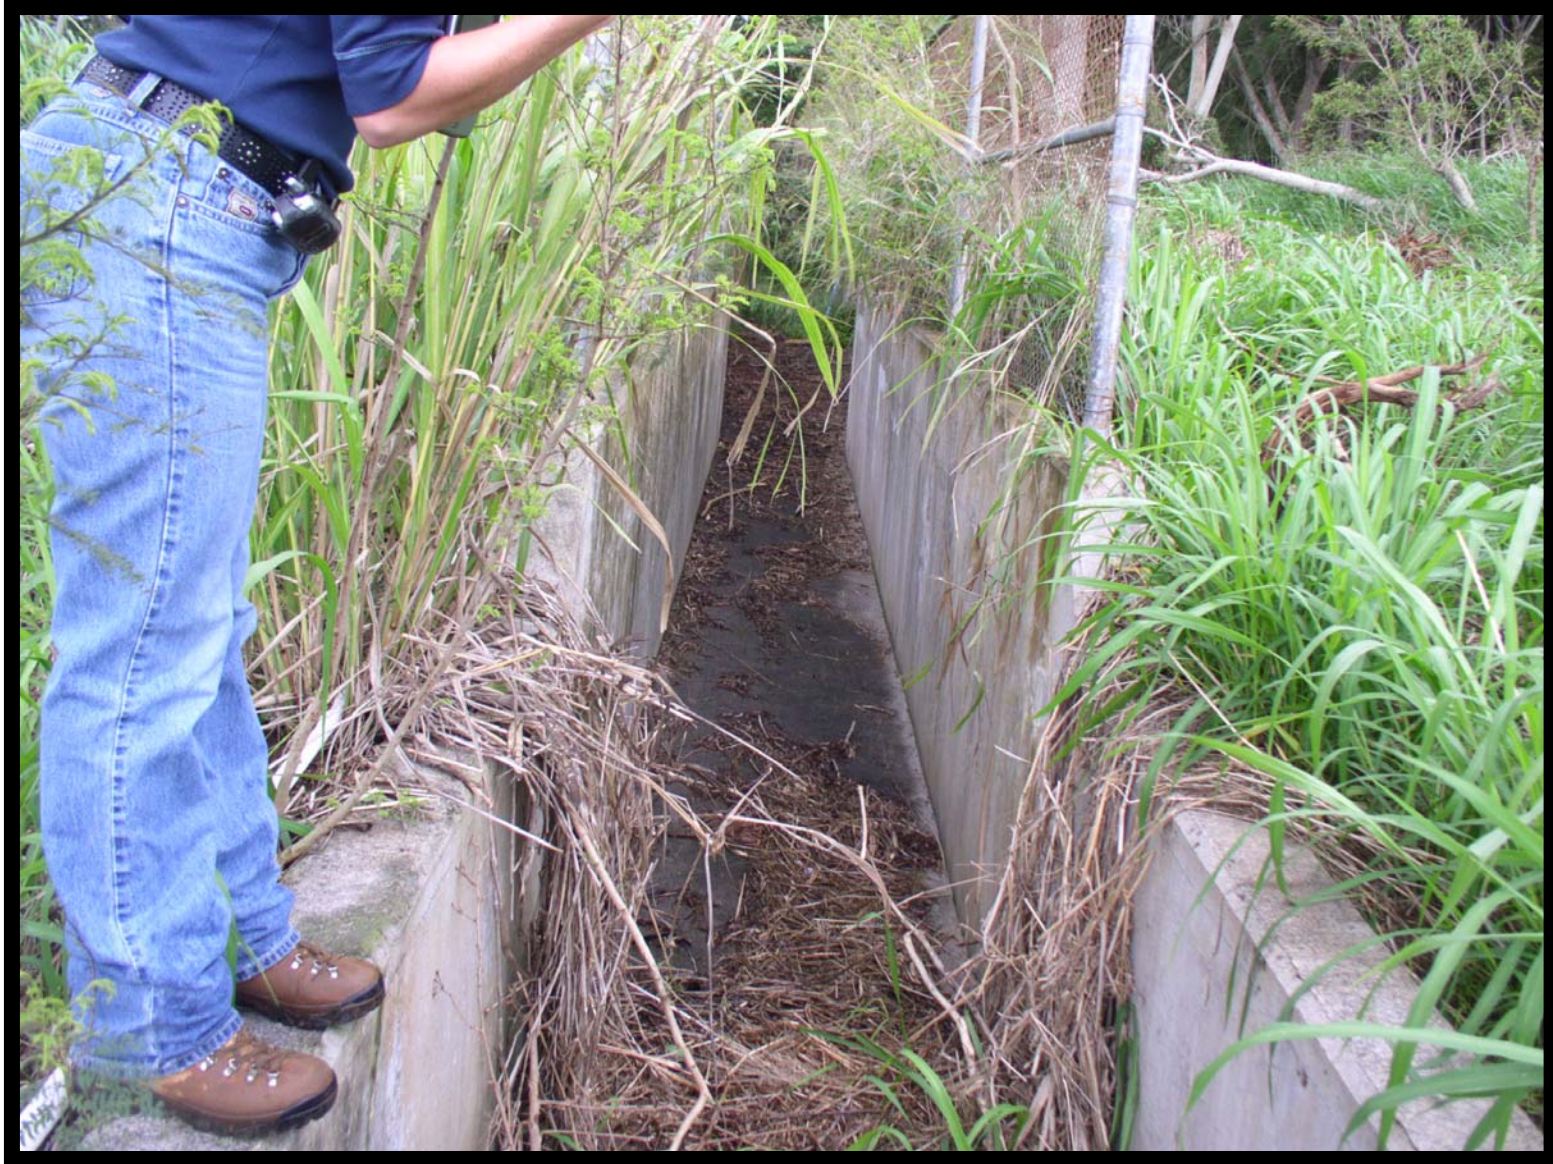
This facility has not been maintained. It seems to function as such with a spillway and outlet channel that is in good condition, despite the lack of maintenance.

125 View of the dam outlet channel, looking upstream.

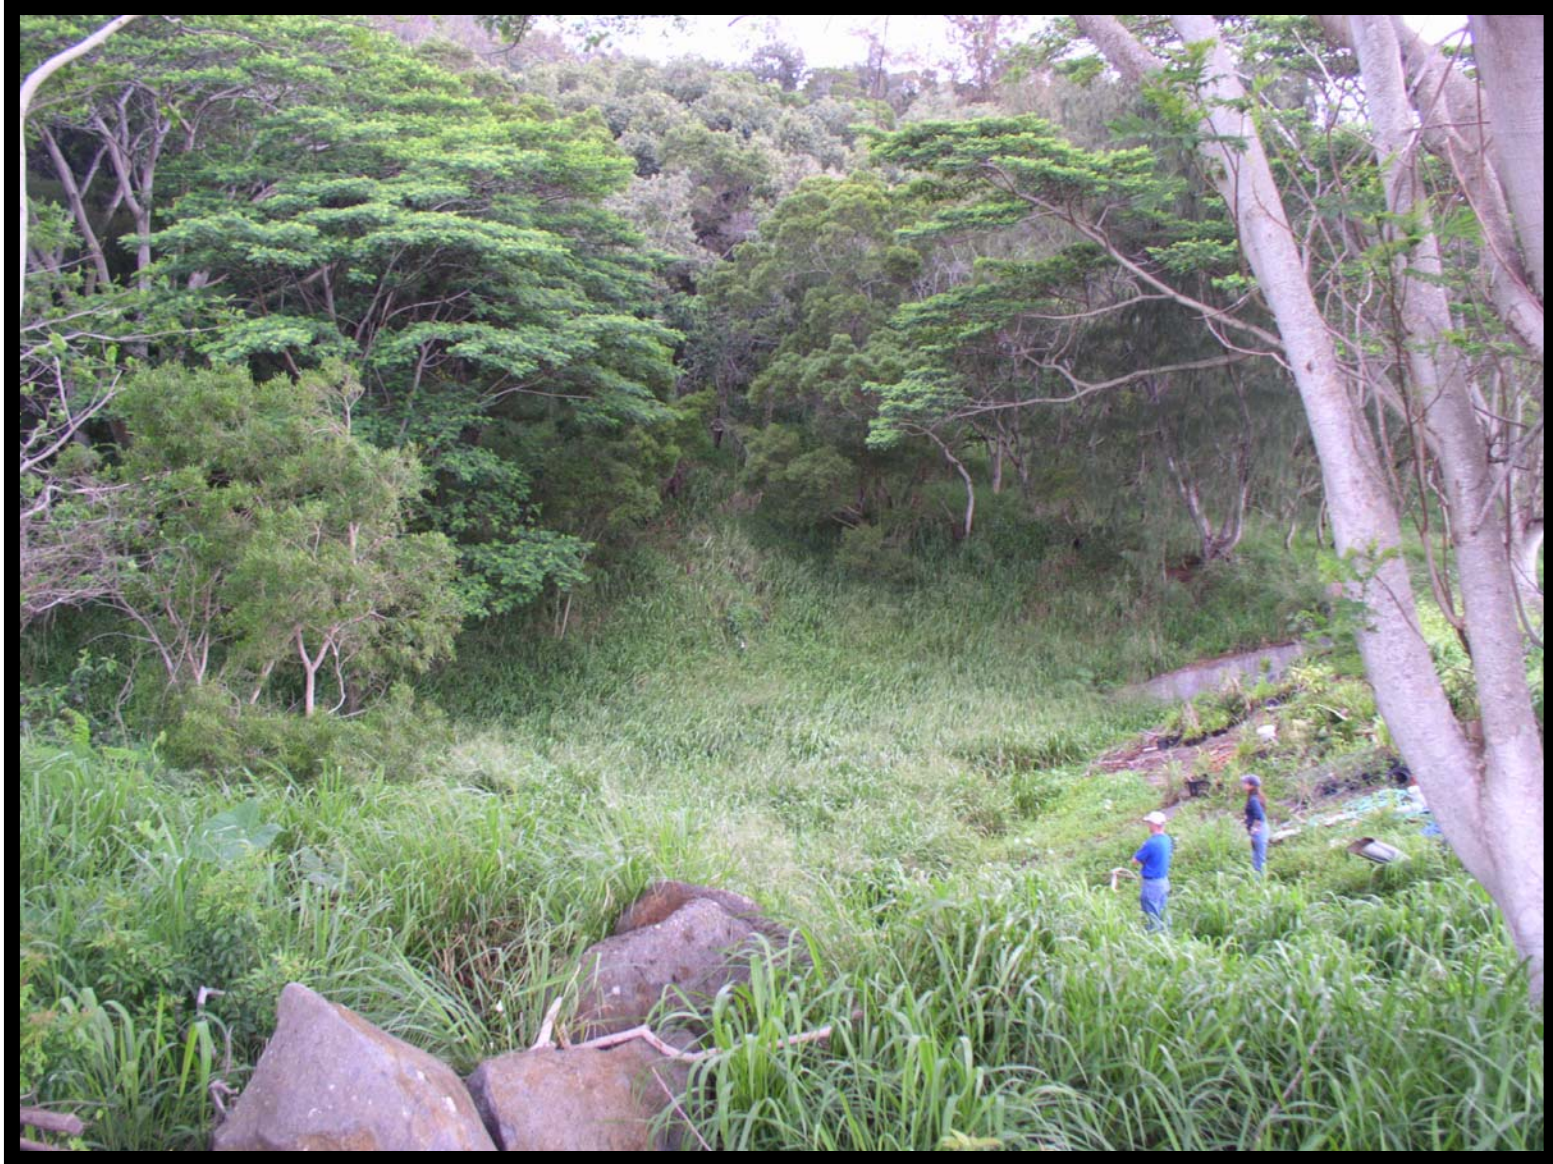
The reservoir was dry at the time of inspection. The normal operating level is unknown and there appears to be no staff gage. The reservoir is overgrown by tall grass and appears to have not been maintained.

- a. The reservoir appeared to be in fair to poor condition and requires corrective action.
- b. A staff gage was not observed in the reservoir. Provide some method of quantifying the water level within the reservoir.
- c. The tall grass in the reservoir needs to be mowed and maintained.

125 Reservoir

Recommend this facility be inspected by its owner and maintained by mowing the high grass in the reservoir and upstream slope.

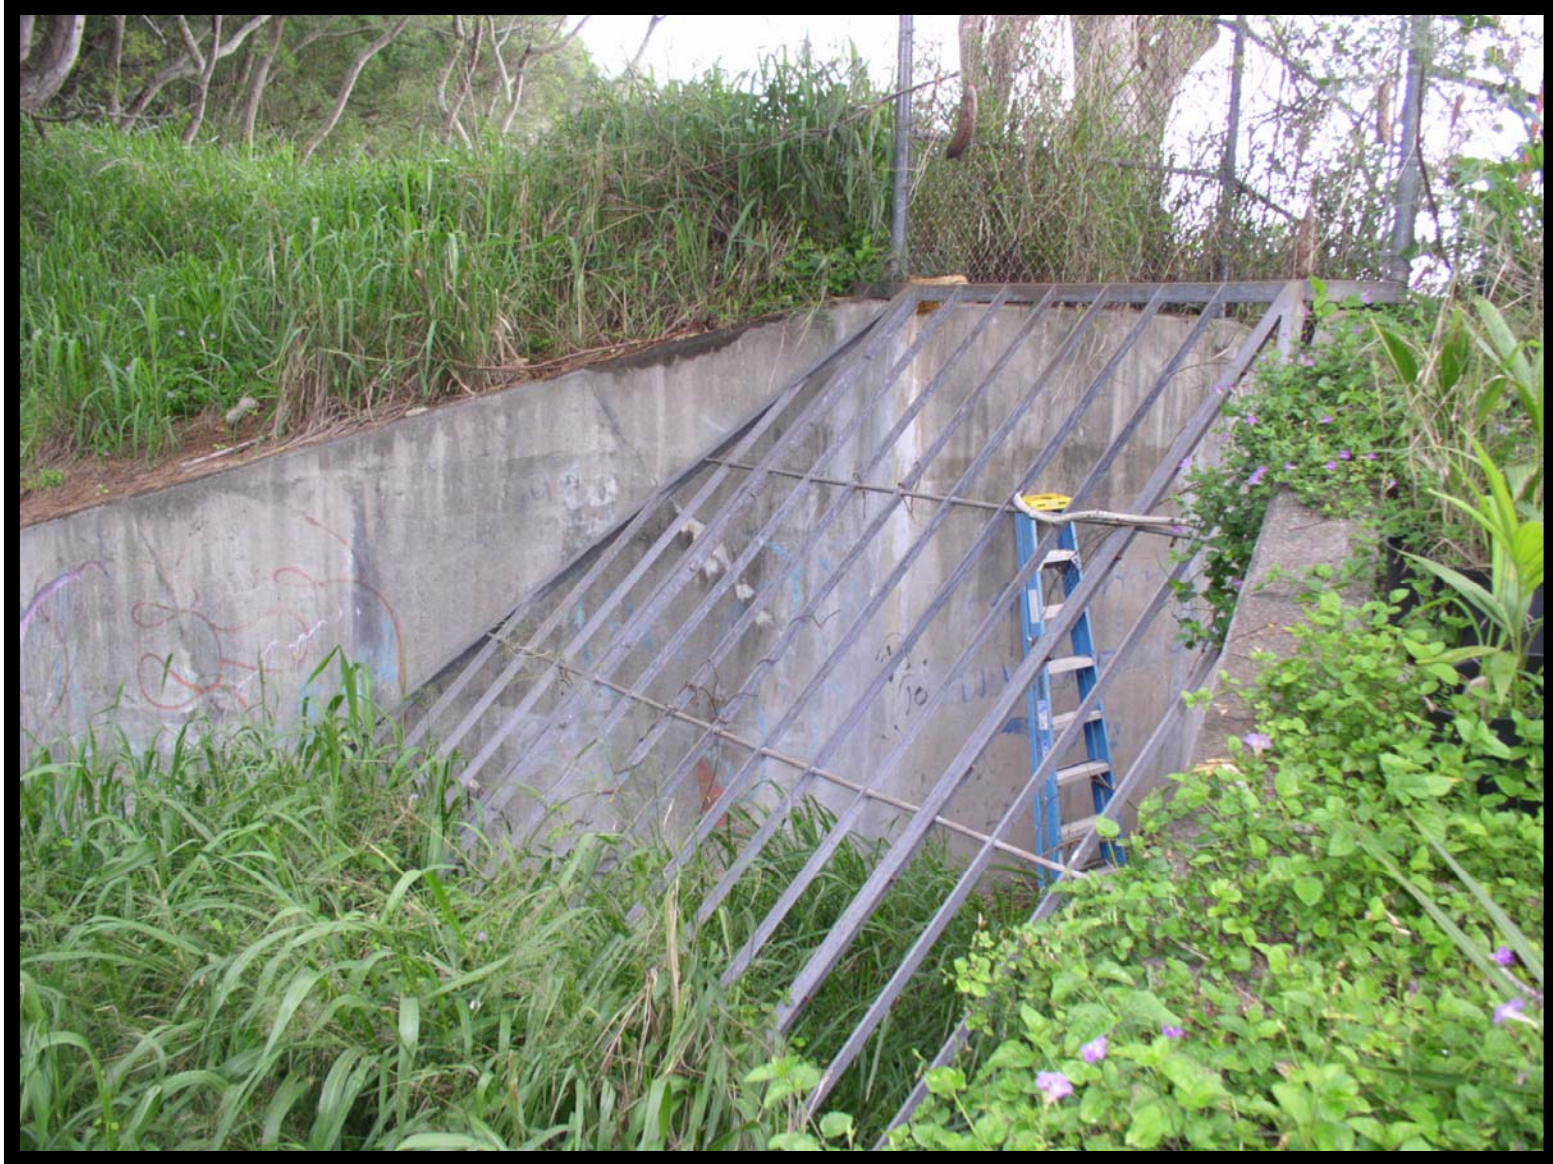
- a. The Spillway appeared to be in satisfactory condition, no corrective actions are required at this time.

125 Spillway – note the trash rack
